Mid-City Plating Co.
INCORPORATED

July 10, 2012

Enclosed are the documents we discussed during our phone conference on June 21, 2012.
We believe that by taking action on these issues, as funds became available, we have
been pro-active.
We also feel that in lieu of fines the money would be better served by correcting
remaining issues.

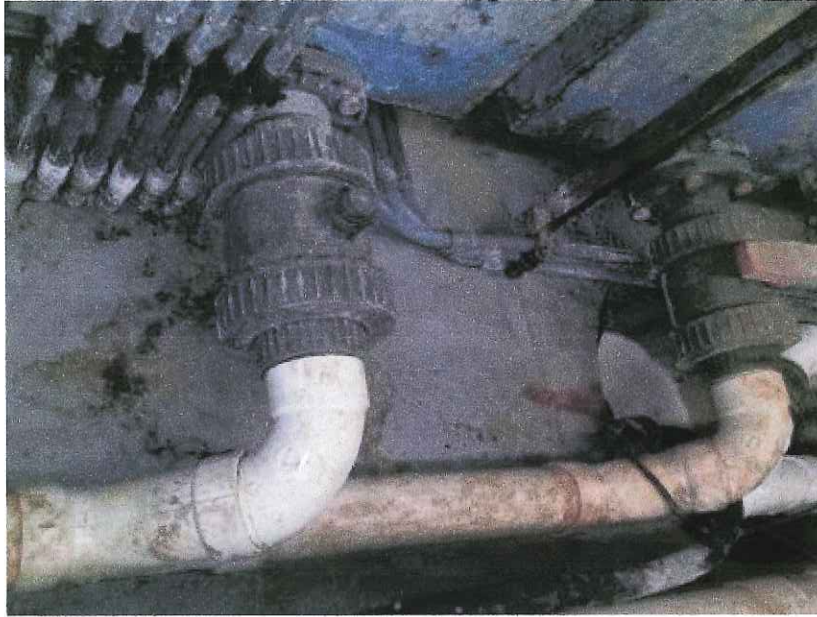
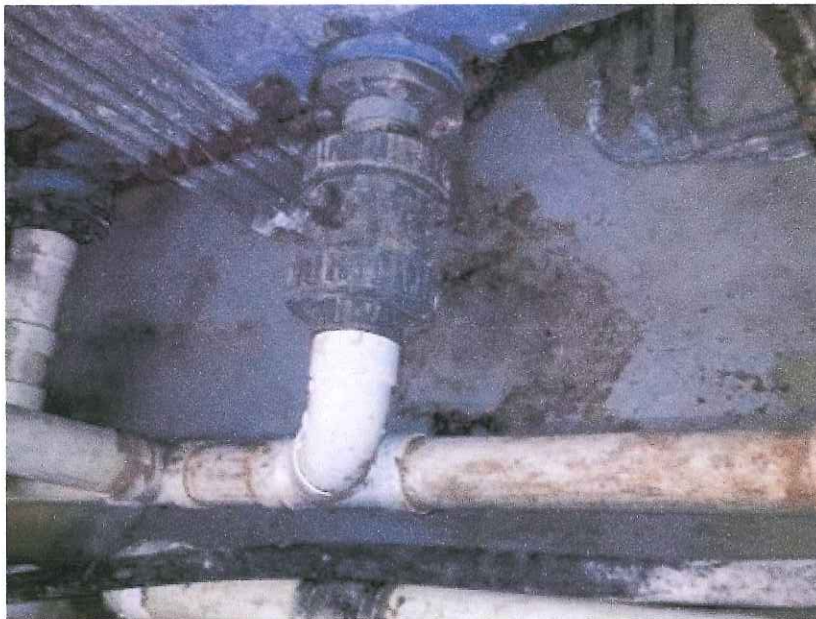
These are pictures of areas of the secondary containment on another line. In the right portion of the first picture you can see the sump area. All liquids removed were fed through existing plumbing to waste treatment. Solids were collected and either put into a F006 1 cubic yard box or F008 drums, manifested and sent off.

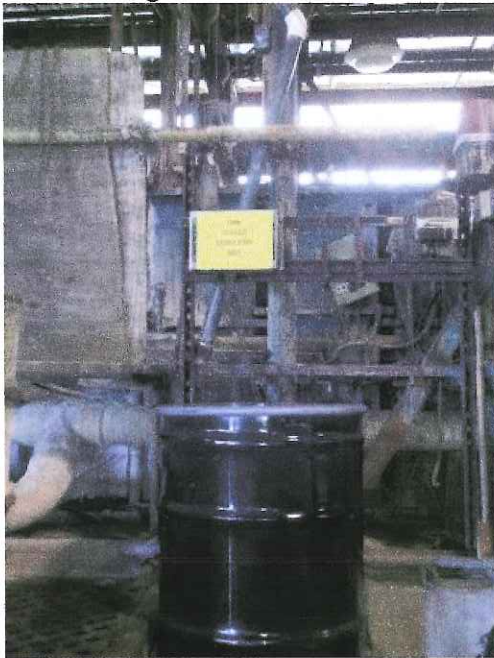
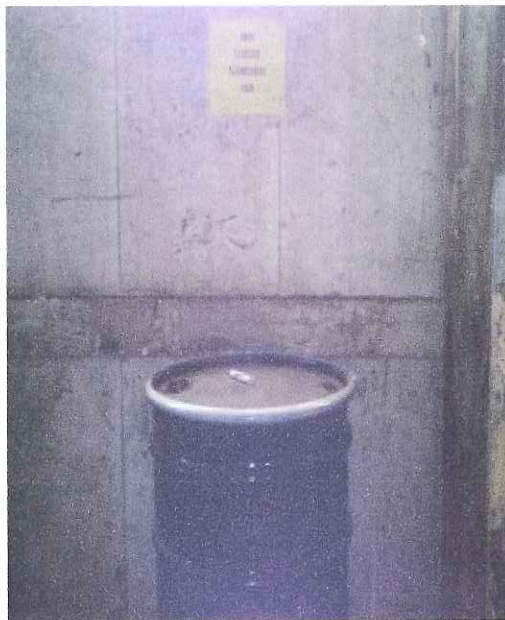
These are pictures of F006 and F008 satellite accumulation areas. Previously, we thought that partial drums of accumulated waste needed to be stored in the designated hazardous waste storage containment area and labeled.

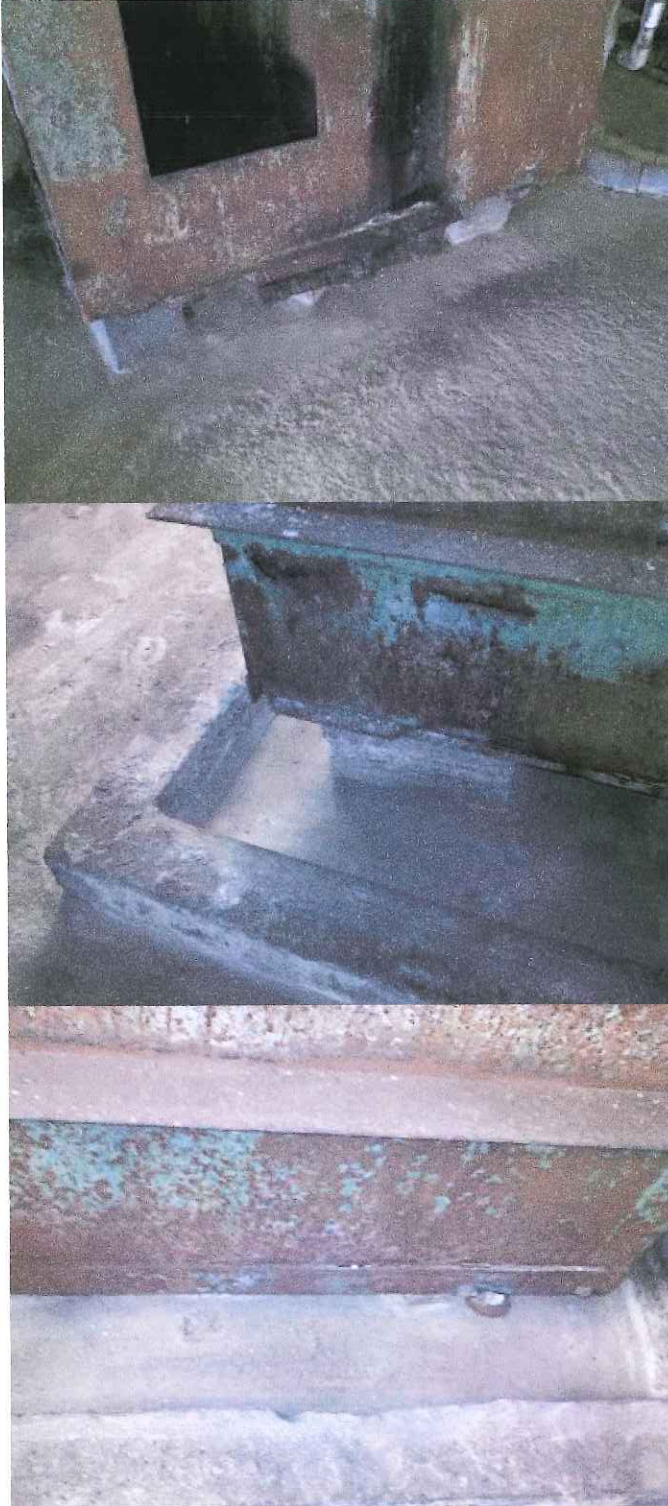
Here are pictures of the machine that had process cleaner residue on the floor at one end and the secondary containment, which had plating solution residue in it, on the other end. The cleaner residue was collected and put into a F006 1 cubic yard roll off, manifested and sent off. The plating solution solids were collected, put into 55 gallon drums, manifested and sent off.

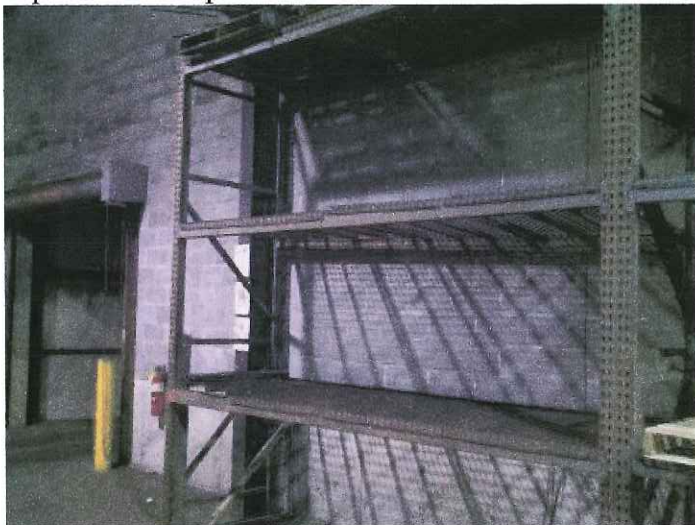
One of the storage racks where empty 55gallon drums were inventoried. Drums were triple rinsed emptied into waste treatment and then destroyed.

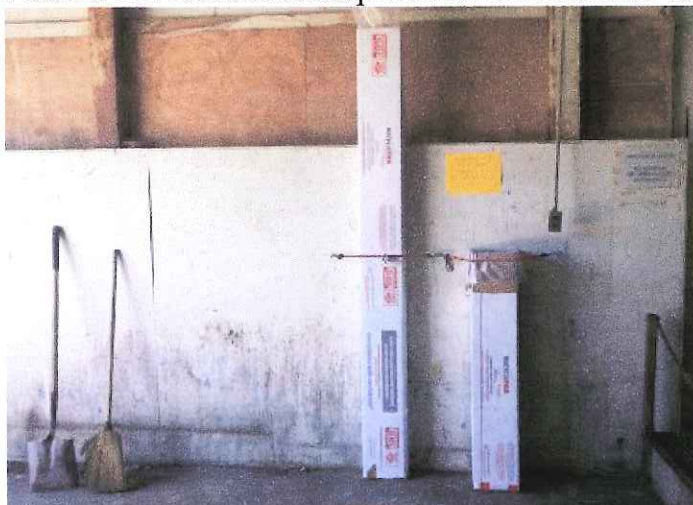
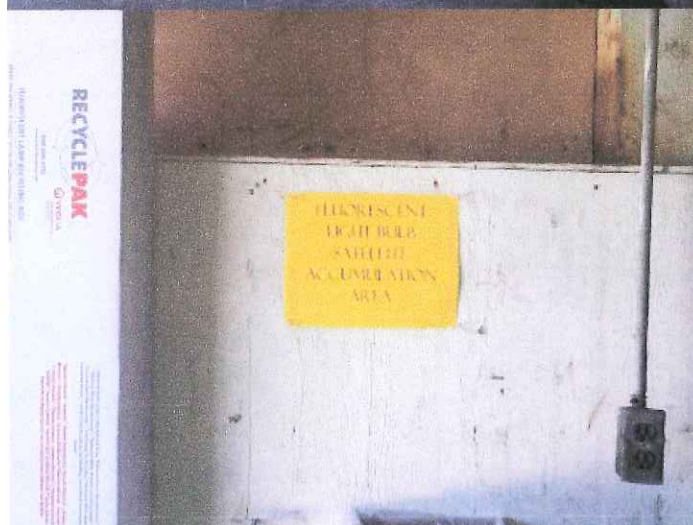
Pictures of Fluorescent lamp satellite accumulation area and Veolia Recycle packs.

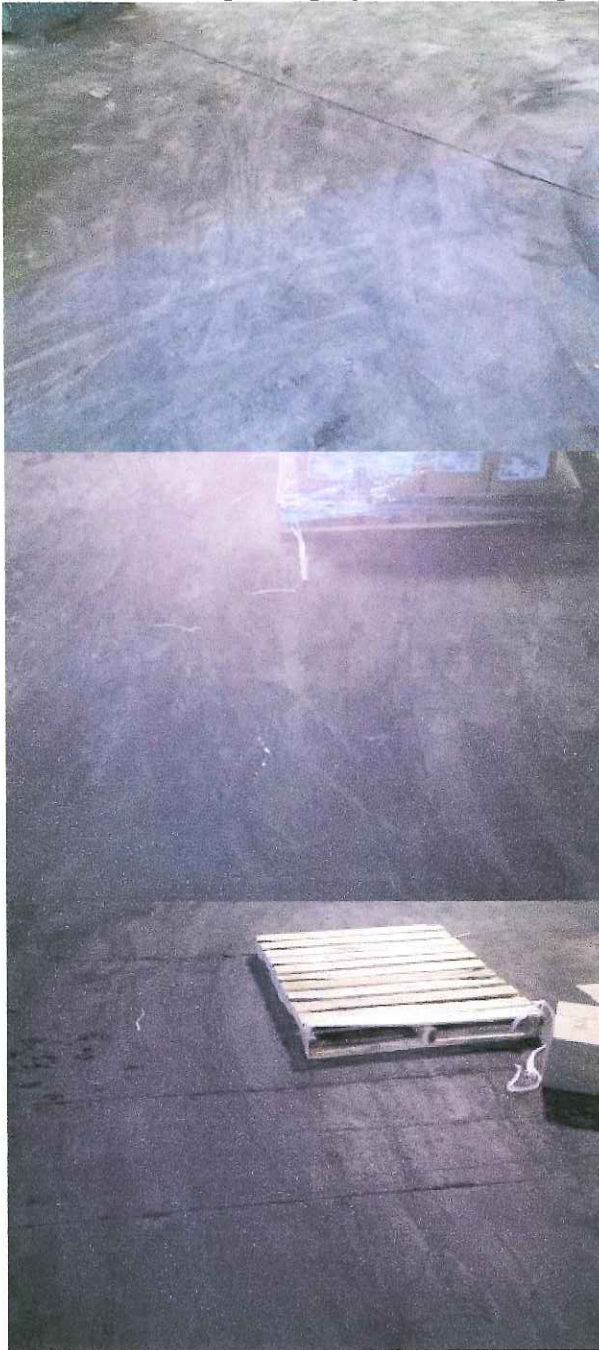
Photos of the standing water “problem areas” from roof leaks. Mid-City Plating contracted two separate projects to address previous issues with roof leaks and wet floors.

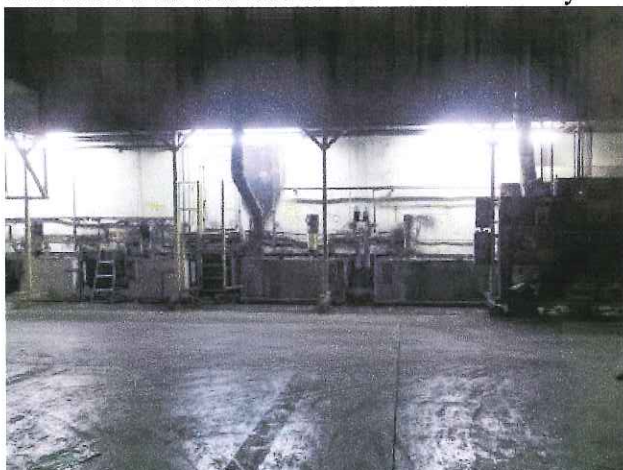
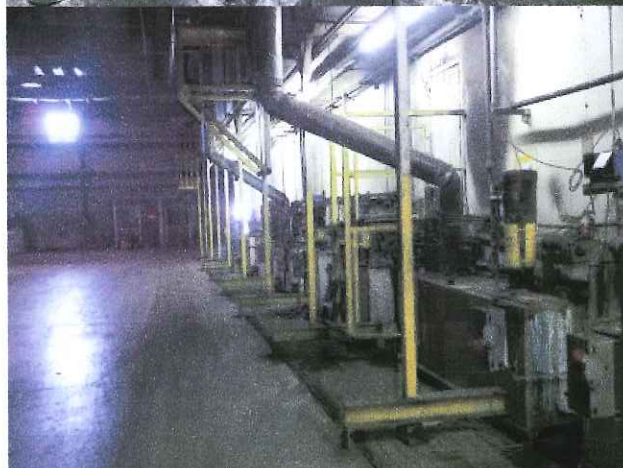
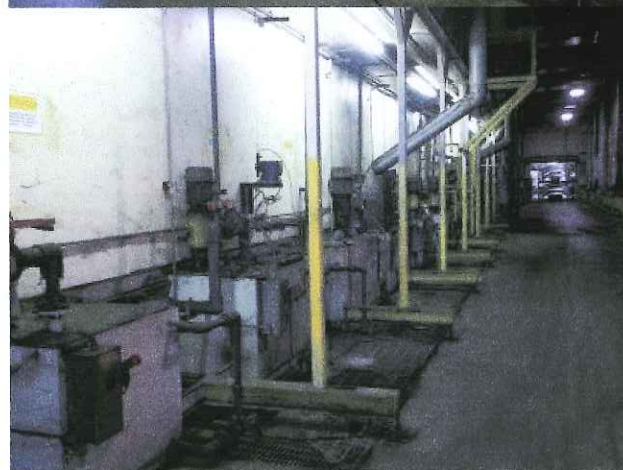
These are pictures of the E-Coat line where buckets of solids and liquids were stored without lids. Product was added to process tanks during normal operation with the exception of one 5 gallon container which had Iron Phosphate residue from riser cleanout. This was added to a F006 1 cubic yard box, manifested and sent off.

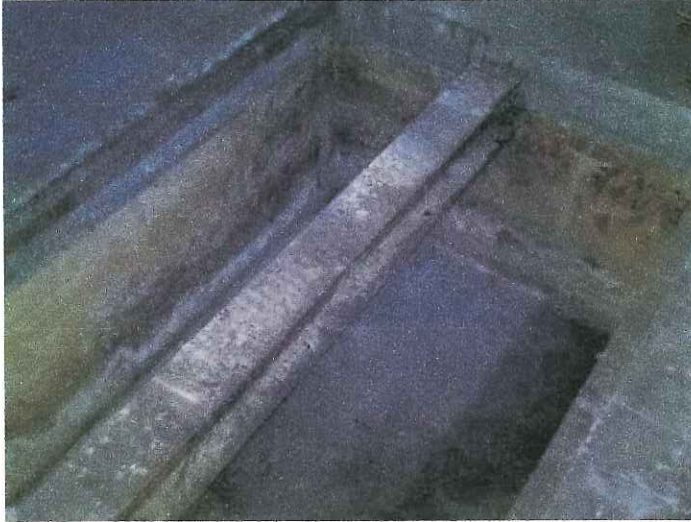
This is a picture of the containment pit that had sludge in it. There was less than 1 inch of sludge in the pit that was from floor cleaning solution, dirt and dust. The sludge was removed and placed into a F006 1 cubic yard box, manifested and sent off.

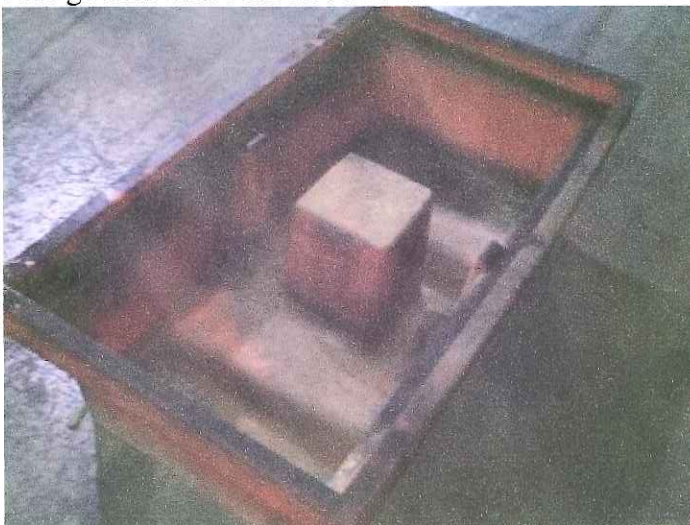
This picture is of a spill containment pallet that had a liquid in the bottom. The liquid was oil that was collected from customer's raw part pans prior to repackaging. Approximately 5.25 gallons was collected and taken to East Central Indiana Recycling.

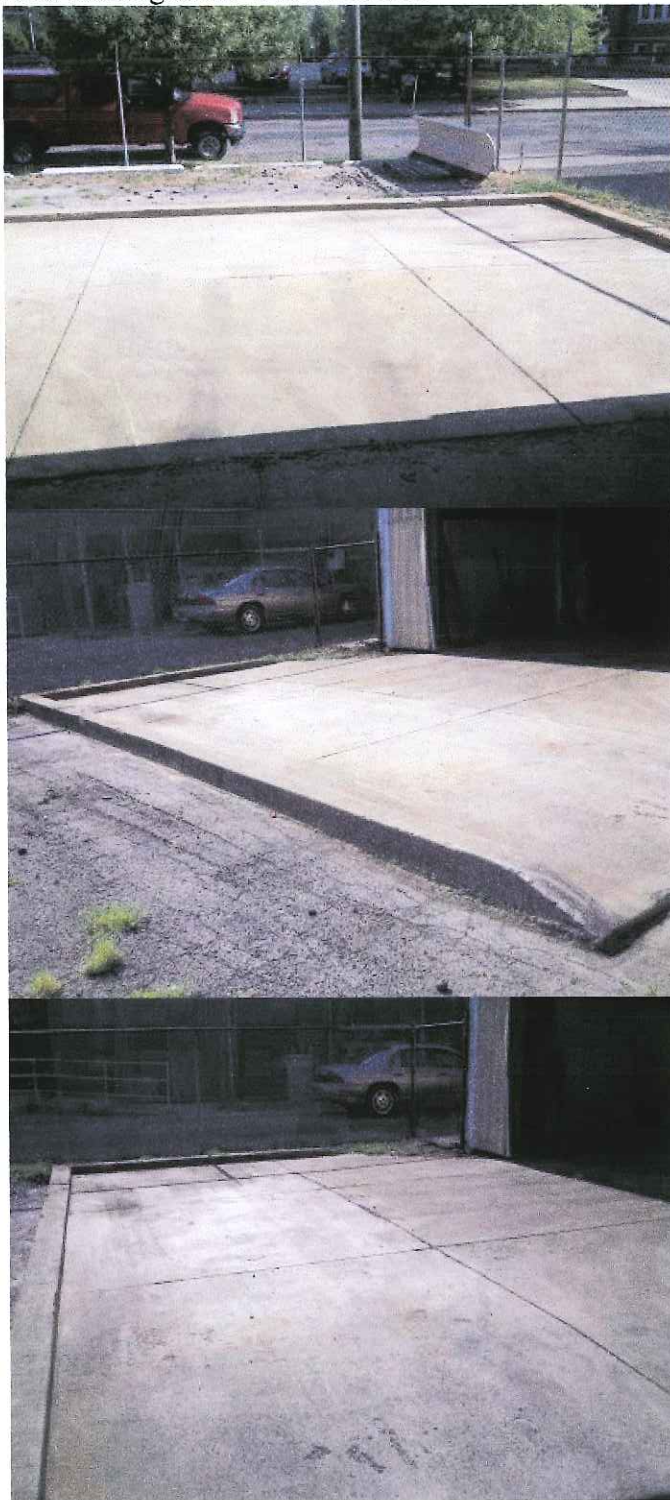
These are pictures of the cement pad where the F006 Roll Off hopper was located. Spillage was collected and placed in a F006 1 cubic yard box, manifested and sent off. Less than 5 gallons was collected.
